# Exploded

H3005 Lateral Raise

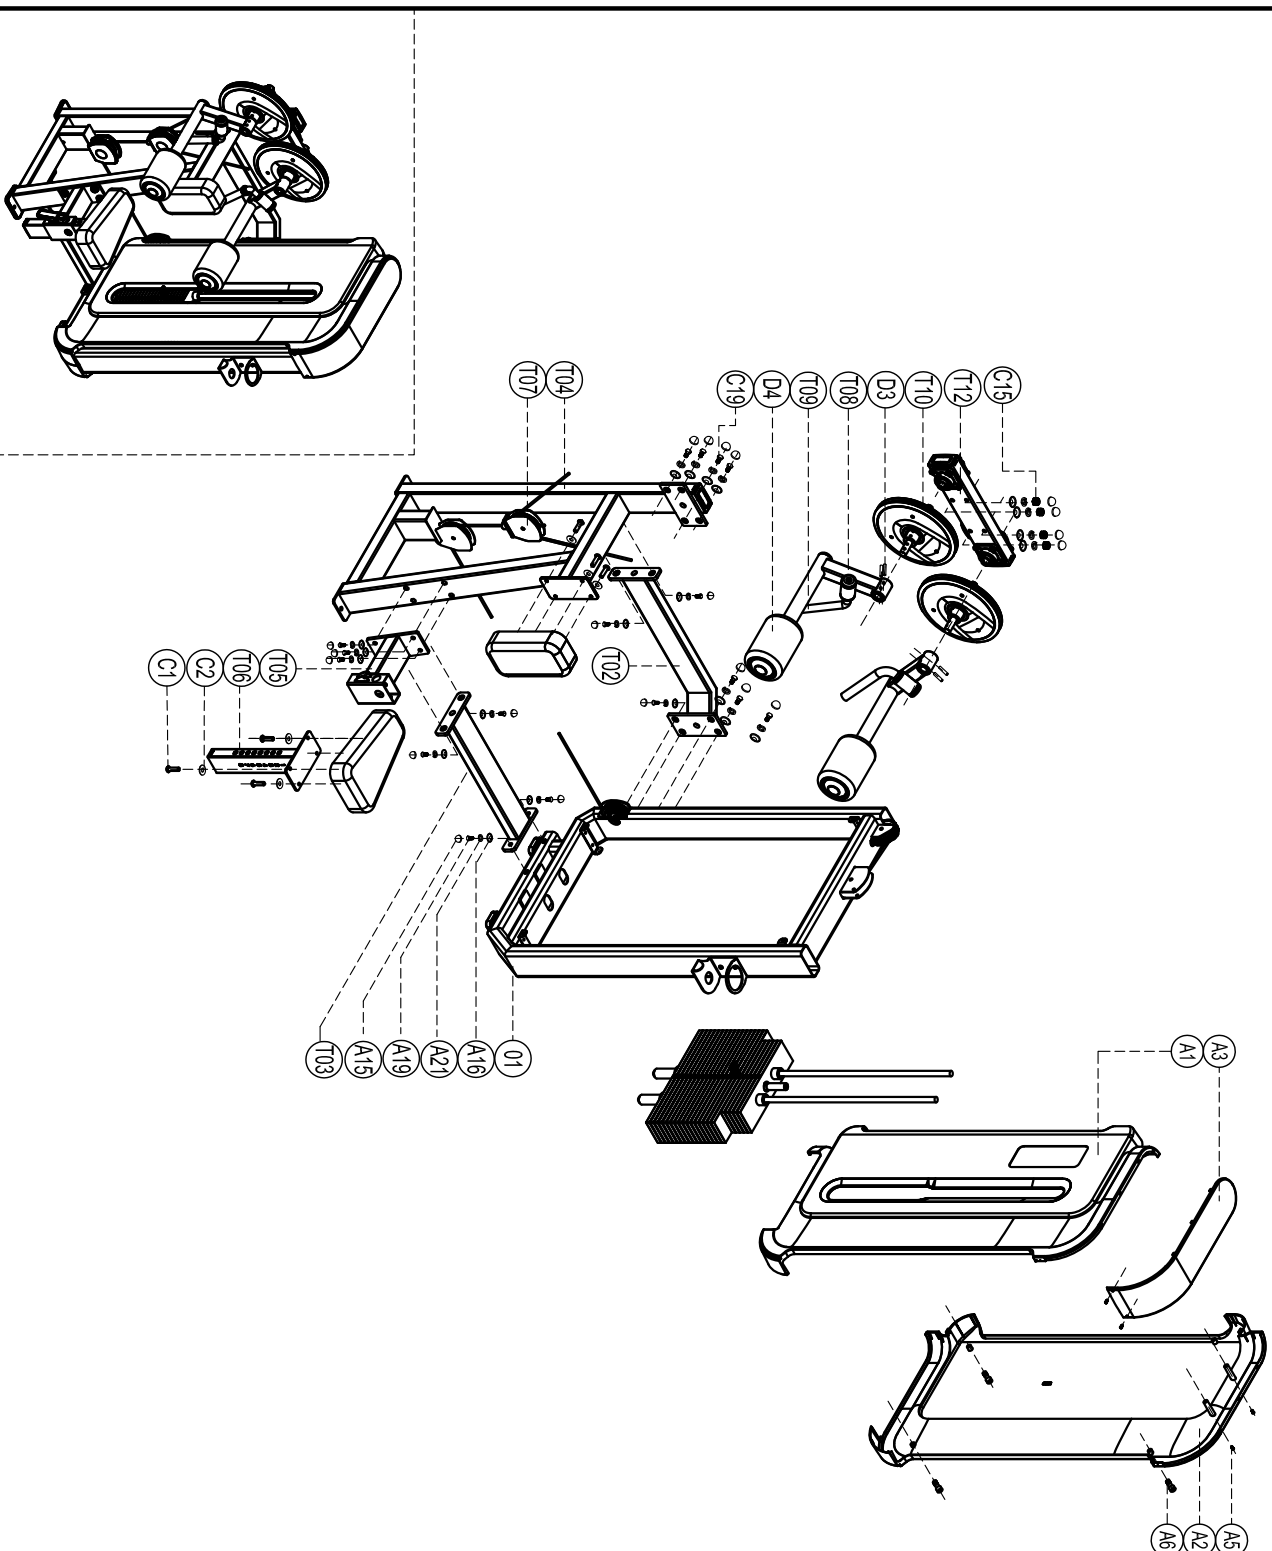
please note :parts didn't demolitionde part and fasteners not listde on the introduction

序号	名称	数量
D4	Foam Frame P1002	1
D3	Pin φ8*50	8
D2	Socket Cap inner hex M10*16	2
C19	Outer hex screw M12*80	4
C15	Self lock nut M12	4
C2	Flat washer φ10	8
C1	Cup head inner hex screw M8*35	8
A21	Spring washer φ12	22
A19	Outer hex screw M12*35	14
A16	Gasket DQ003	22
A15	Screw cap S208	22
A6	Cup head inner hex screw M5*15	8
A5	Cup head cross tapping screw ST3*8	4
A3	Top cover	1
A2	Back shroud	1
A1	Front shroud	1
12	Bearing fixing	1
10	Cam frame	2
09	Handle frame	2
08	Working arm	2
07	Pulley set frame	1
06	Seat fixing frame	1
05	Cusion selection	1
04	Main frame	1
03	Bottom connector	1
02	Bent frame set	1
01	Door frame	1
